No.76 IACS Guidelines for Surveys, Assessment and Repair of Hull Structure – Bulk Carriers

Guidelines for Surveys, Assessment and Repair of Hull
Structure

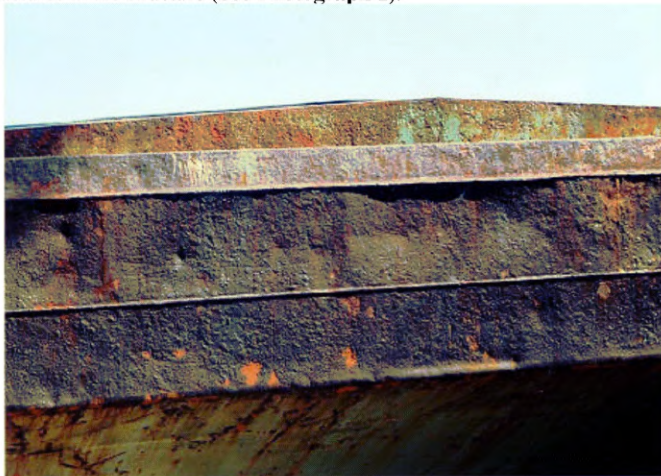
- 3.1.1 The level of wastage of under-deck stiffeners/structure in cross deck may have to be established by means of thickness measurements. The combined effect of the marine environment and the high humidity atmosphere within cargo hold s will give rise to a high corrosion rate.
- 3.1.2 Severe corrosion of the hatch coaming plating inside cargo hold and topside tank plating vertical strake may occur due to difficult access for the maintenance of the protective coating. This may lead to fractures in the structure (See **Photograph 1**).

Photograph 1 Heavy corrosion of hatch coaming and topside tank plating vertical strake

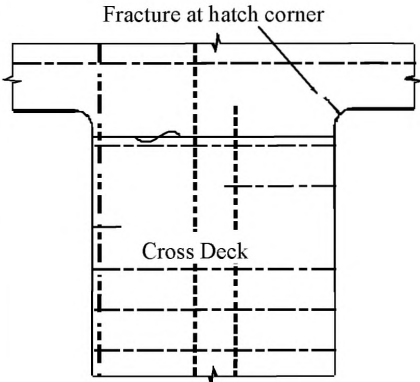
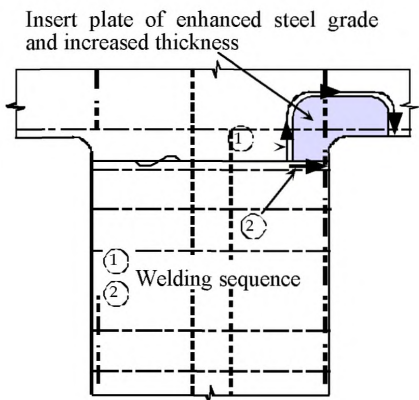
BULK CARRIERS		Guidelines for Surveys, Assessment and Repair of Hull Structure	
Part 1	Cargo hold region	Example No.	
Area 1	Deck structure	1	
Detail of damage		Fractures at main cargo hatch corner	
Sketch of damage

Notes on possible cause of damage <ol style="list-style-type: none"> 1. Stress concentration at hatch corners, i.e. radius of corner. 2. Welded attachment of shedder plate close to edge of hatch corner. 3. Wire rope groove. 		Notes on repairs <ol style="list-style-type: none"> 1. The corner plating in way of the fracture is to be cropped and renewed. If stress concentration is primary cause, insert plate should be increased thickness, enhanced steel grade and/or improved geometry. Insert plate should be continued beyond the longitudinal and transverse extent of the hatch corner radius ellipse or parabola, and the butt welds to the adjacent deck plating should be located well clear of the butts in the hatch coaming. It is recommended that the edges of the insert plate and the butt welds connecting the insert plates to the surrounding deck plating be made smooth by grinding. In this respect caution should be taken to ensure that the micro grooves of the grinding are parallel to the plate edge. 2. If the cause of fracture is welded attachment of shedder plate, the deck connection should be left unwelded. 3. If the cause of the fracture is wire rope groove, replacement to the original design can be accepted.

Sketch of repair Insert plate of enhanced steel grade and increased thickness

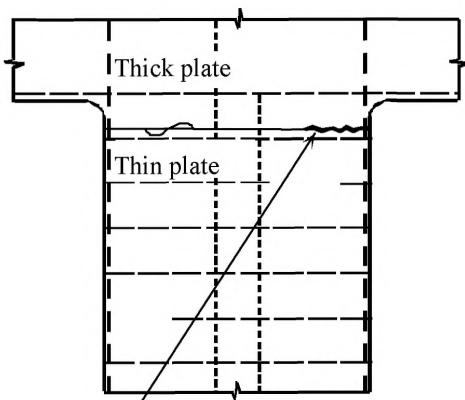
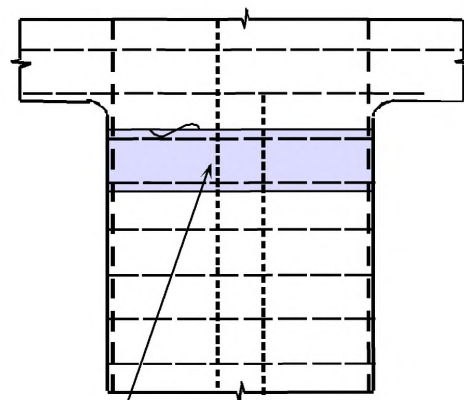
BULK CARRIERS		Guidelines for Surveys, Assessment and Repair of Hull Structure	
Part 1	Cargo hold region	Example No.	
Area 1	Deck structure	2-a	
Detail of damage		Fractures of welded seam between thick plate and thin plate at cross deck	
<p>Sketch of damage</p>

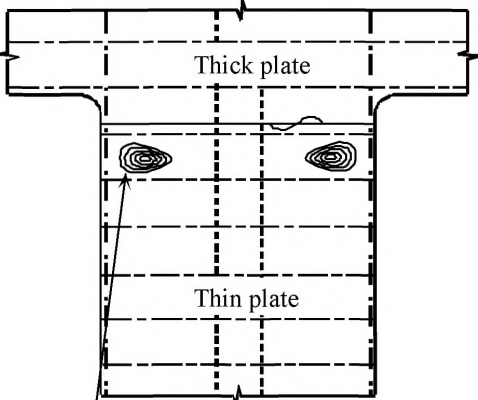
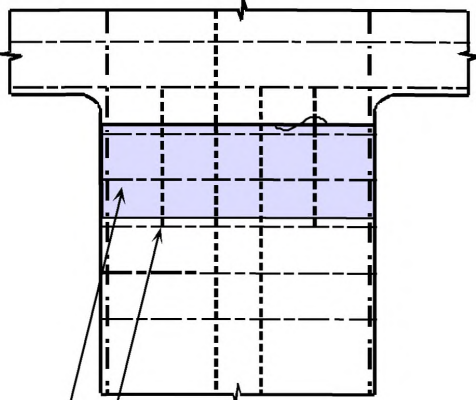
BULK CARRIERS		Guidelines for Surveys, Assessment and Repair of Hull Structure	
Part 1	Cargo hold region	Example No.	
Area 1	Deck structure	2-b	
Detail of damage		Plate buckling in thin plate near thick plate at cross deck	
Sketch of damage		Sketch of repair

<p>Buckling of cross deck plating (Buckling of hatch end structure should be examined. Refer to Example 7-a.)</p>

<p>Additional transverse stiffening and/or insertion of plate with suitable intermediate thickness</p>	
Notes on possible cause of damage		Notes on repairs	
<ol style="list-style-type: none"> 1. In-plane bending of cross deck strip due to torsional (longitudinal) movement of ship sides, often in combination with corrosion. 2. Insufficient plate thickness and/or transverse stiffening. 		<ol style="list-style-type: none"> 1. Transverse stiffeners extending from hatch sides towards centerline at least 10% of breadth of hatch, and/or increased plate thickness in the same area.

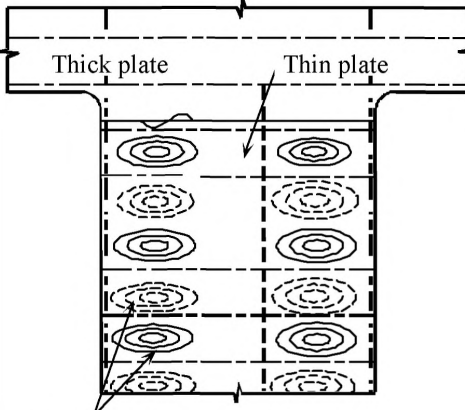
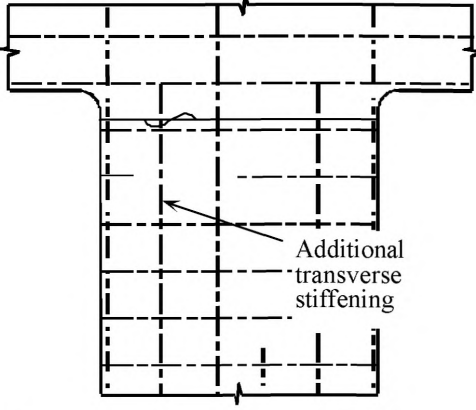
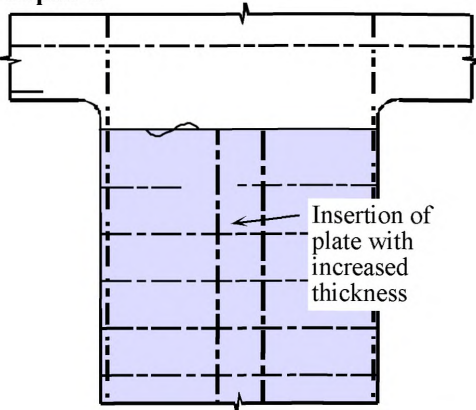
BULK CARRIERS		Guidelines for Surveys, Assessment and Repair of Hull Structure	
Part 1	Cargo hold region	Example No.	
Area 1	Deck structure	2-c	
Detail of damage		Overall buckling of cross deck plating	
<p>Sketch of damage</p>

<p>Buckling of cross deck plating (Buckling of hatch end structure should be examined. Refer to Example 7-a.)</p>		<p>Sketch of repair</p> <p>Repair A</p>

<p>Notes on possible cause of damage</p> <ol style="list-style-type: none"> 1. Transverse compression of deck due to sea load. 2. Transverse compression of deck due to excessive loading in two adjacent holds. 3. Insufficient plate thickness and/or transverse stiffening. 		<p>Notes on repairs</p> <ol style="list-style-type: none"> 1. Repair A Plating of original thickness in combination with additional transverse stiffening. 2. Repair B Insertion of plating of increased thickness.

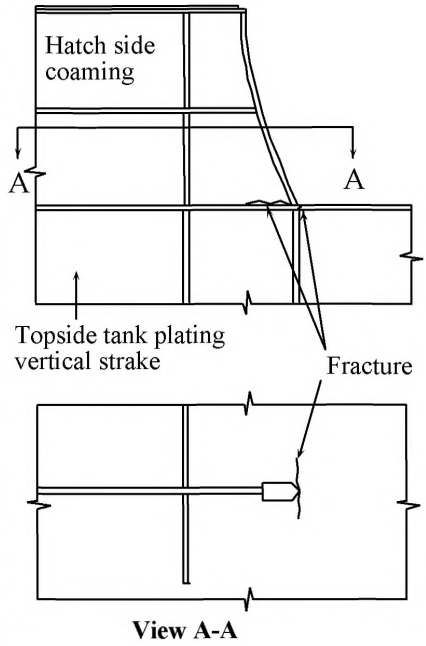
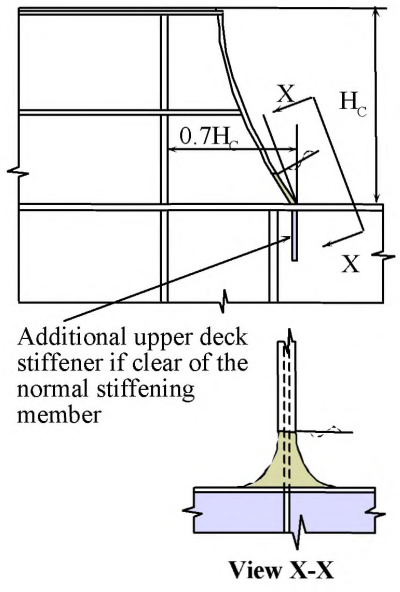
BULK CARRIERS		Guidelines for Surveys, Assessment and Repair of Hull Structure	
Part 1	Cargo hold region	Example No.	
Area 1	Deck structure	3-a	
Detail of damage		Fractures in the web or in the deck at the toes of the longitudinal hatch coaming termination bracket	
<p>Sketch of damage</p>

<p>Notes on possible cause of damage</p> <ol style="list-style-type: none"> 1. This damage is caused by stress concentrations attributed to the design of the bracket. 		<p>Notes on repairs</p> <ol style="list-style-type: none"> 1. The design of the bracket can be altered as shown above, however, it is to be ensured that an additional under deck stiffener is provided at the toe of the termination bracket, where the toe is clear of the normal stiffening member. 2. Full penetration weld for a distance of $0.15 H_C$ from toe of side coaming termination bracket and for connection of athwartship gusset bracket to deck. 3. The fracture in deck plating to be veed-out and rewelded or deck plating cropped and part renewed as appropriate, using low hydrogen electrodes for welding.

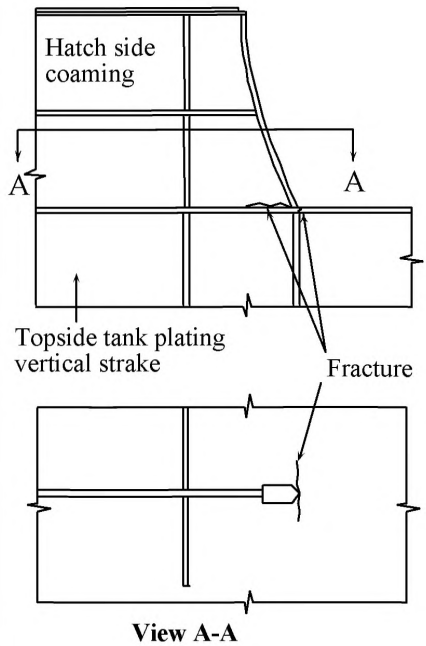
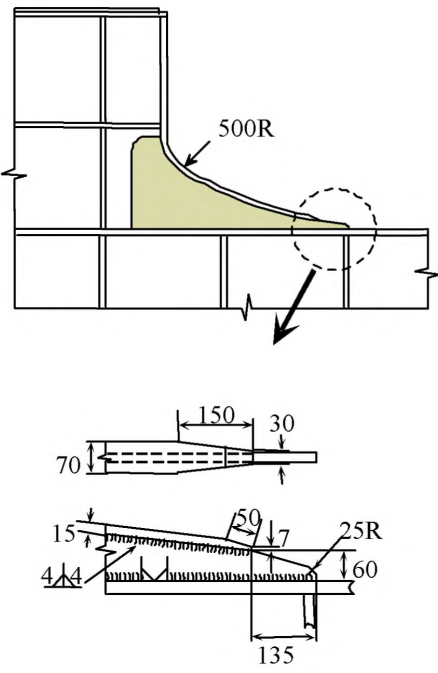
BULK CARRIERS		Guidelines for Surveys, Assessment and Repair of Hull Structure	
Part 1	Cargo hold region	Example No.	
Area 1	Deck structure	3-b	
Detail of damage		Fractures in the web or in the deck at the toes of the longitudinal hatch coaming termination bracket	
<p>Sketch of damage</p>

<p>500R</p> <p>150 30</p> <p>70</p> <p>15 4 4 50 7 60</p> <p>135</p>	
<p>Notes on possible cause of damage</p> <ol style="list-style-type: none"> 1. This damage is caused by stress concentrations attributed to the design of the bracket. 		<p>Notes on repairs</p> <ol style="list-style-type: none"> 1. The design of the bracket can be altered as shown above, however, it is to be ensured that an additional under deck stiffener is provided at the toe of the termination bracket, where the toe is clear of the normal stiffening member. 2. The fracture in deck plating to be veed-out and rewelded or deck plating cropped and part renewed as appropriate, using low hydrogen electrodes for welding.

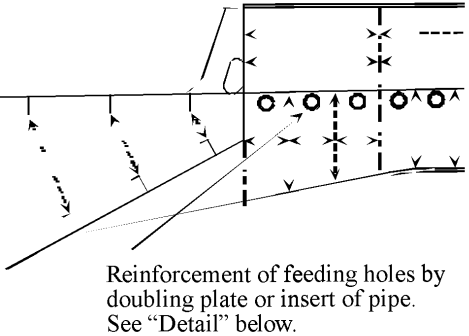
<p style="text-align: center;">Detail</p>	
Notes on possible cause of damage 1. Inadequate reinforcement around feeding hole. 2. Corrosion.		Notes on repairs 1. Fractured part to be veed-out or cropped and renewed. 2. If the fractured part is free from corrosion, reinforcement should be considered.

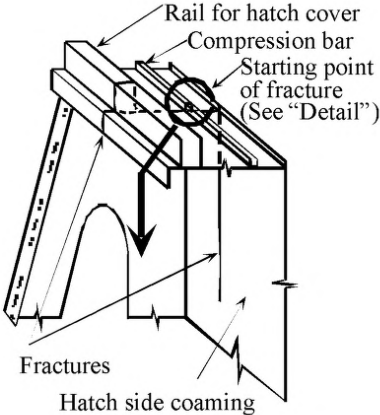
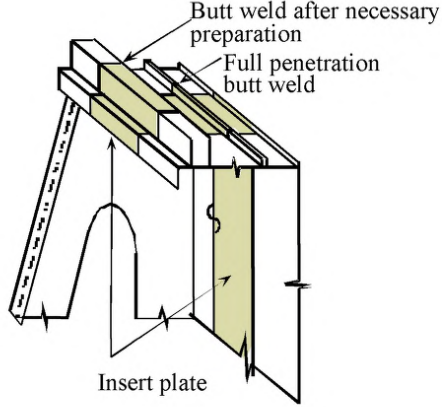
BULK CARRIERS		Guidelines for Surveys, Assessment and Repair of Hull Structure	
Part 1	Cargo hold region	Example No.	
Area 1	Deck structure	11	
Detail of damage	Fractures in hatch coaming top plate initiated from butt weld of compression bar		
<p>Sketch of damage</p>

<p>Notes on possible cause of damage</p> <ol style="list-style-type: none"> 1. Heavy weather 2. Insufficient preparation of weld of compression bar and/or rail (Although the compression bar and rail are not longitudinal strength members, they subject same longitudinal stress as longitudinal members) 3. Crack may initiate from insufficient penetration of weld of rail for hatch cover. 		<p>Notes on repairs</p> <ol style="list-style-type: none"> 1. Loading condition of the ship and proper welding procedure should be carefully considered. 2. Fractured structure is to be cropped and renewed if considered necessary. (Small fracture may be vee-d-out and rewelded.) 3. Full penetration welding should be applied to the butt weld of compression bar and rail.

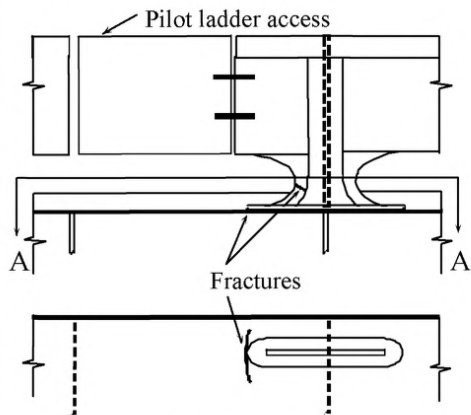
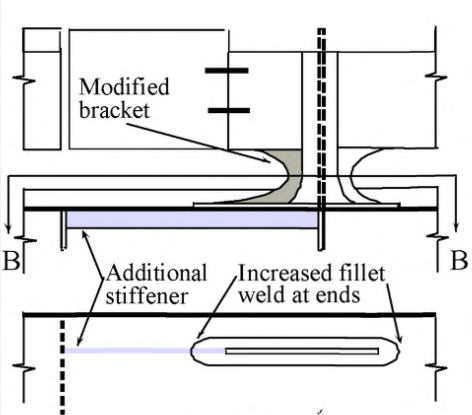
<p>View B-B</p>	
<p>Notes on possible cause of damage</p> <ol style="list-style-type: none"> 1. Stress concentration at the termination of bulwarks. 		<p>Notes on repairs</p> <ol style="list-style-type: none"> 1. Fractured deck plating should be cropped and part renewed. 2. Reduction of stress concentration should be considered. In the above figure gusset plate was replaced with soft type for the fracture in gusset plate and pad plate was increased. Additional stiffeners were provided for the fracture in deck plating.

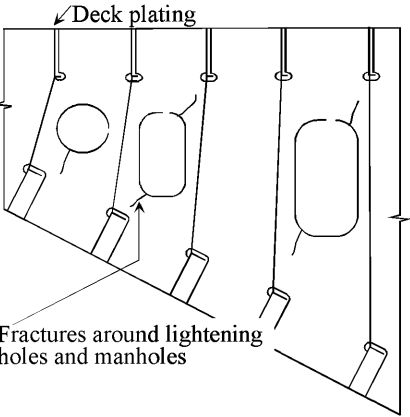
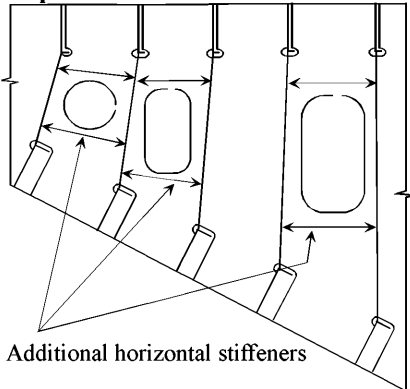
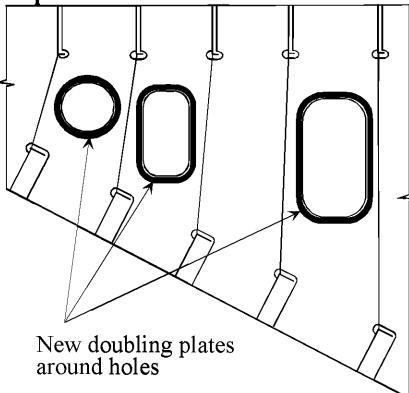
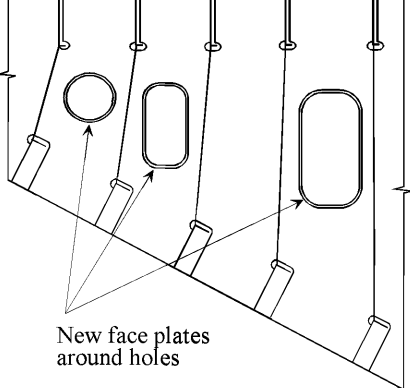
<p>Deck plating</p> <p>Fractures around lightening holes and manholes</p>		Sketch of repair Repair A

<p>New face plates around holes</p>	
Notes on possible cause of damage 1. General levels of corrosion and presence of stress concentration.		Notes on repairs 1. Corroded/fractured plate should be cropped and renewed with plating of enhanced thickness. 2. Reinforcement should be considered.

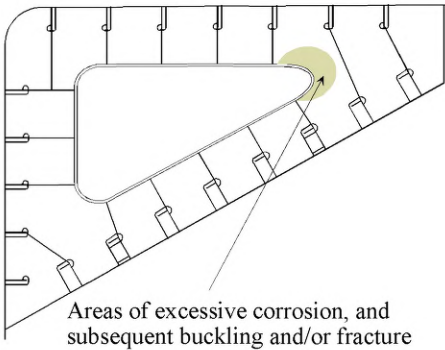
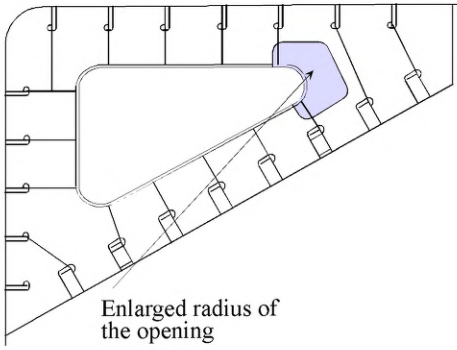
<p>Areas of excessive corrosion, and subsequent buckling and/or fracture</p>

<p>Enlarged radius of the opening</p>	
Notes on possible cause of damage		Notes on repairs	
<ol style="list-style-type: none"> Corrosion caused by stress concentration at the corner due to insufficient radius for the opening. 		<ol style="list-style-type: none"> Corroded/buckled plating is to be cropped and parts renewed with plating of increased thickness and additional stiffeners are preferable to minimize deflection. An attempt should be made to improve the design of the radius if felt necessary.

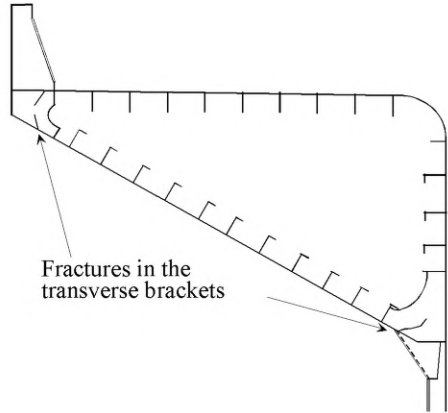
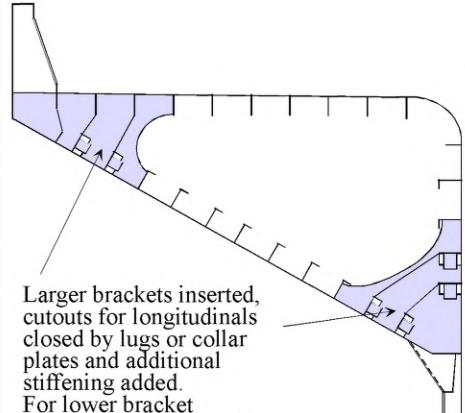
<p>Fractures in the transverse brackets</p>

<p>Larger brackets inserted, cutouts for longitudinals closed by lugs or collar plates and additional stiffening added. For lower bracket alternatively increase the thickness</p>	
Notes on possible cause of damage		Notes on repairs	
<ol style="list-style-type: none"> 1. General levels of corrosion and presence of stress concentrations. 2. Misalignment of the brackets with adjoining structure, e.g. side shell frame brackets and/or coaming brackets. 3. High shear stresses due to insufficient bracket size. 4. Inadvertent overloading. 		<ol style="list-style-type: none"> 1. If the damage is caused by misalignment with the side shell frame brackets or the hatch coaming brackets the misalignment is to be rectified and the replacement by larger brackets incorporated only if considered necessary.

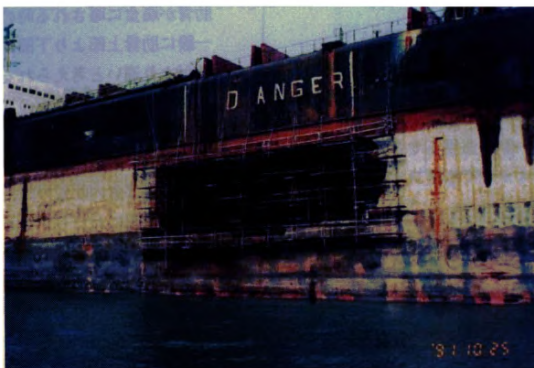
Photograph 2 Missing side shell structure (See Examples 4 and 5)

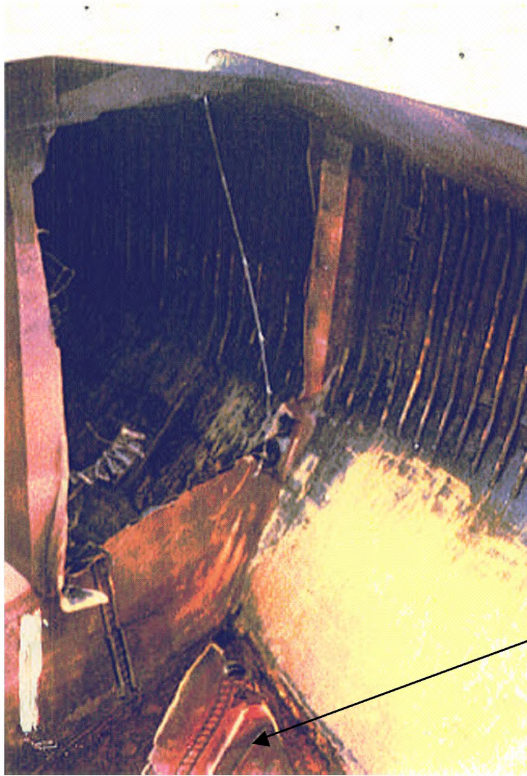
Photograph 1
Collapsed and detached
transverse bulkhead

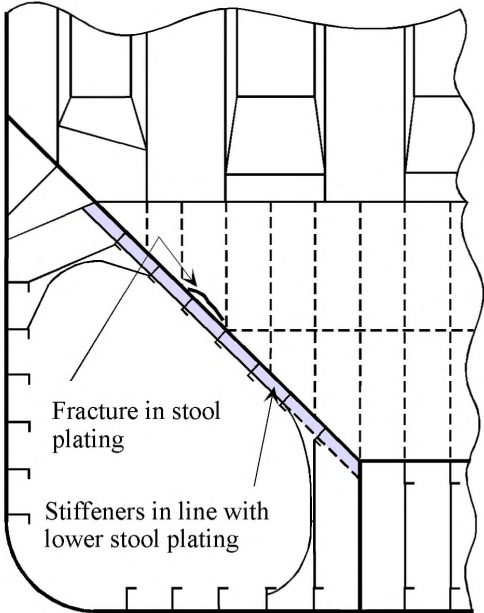
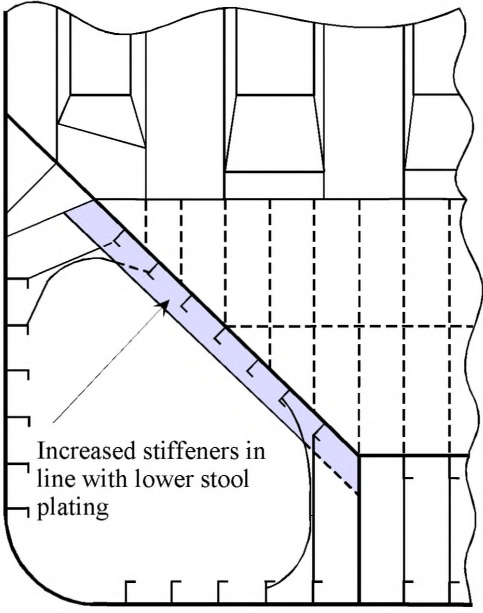
<p>Fracture in stool plating</p> <p>Stiffeners in line with lower stool plating</p>

<p>Increased stiffeners in line with lower stool plating</p>	
Notes on possible cause of damage		Notes on repairs	
<ol style="list-style-type: none"> 1. Insufficient strength of the connection 2. Corrosion 		<ol style="list-style-type: none"> 1. Fractured stool plating should be partly cropped and renewed (thicker plate) if considered necessary. 2. If the damage occurred due to insufficient strength, stiffeners in line with stool plating should be increased.

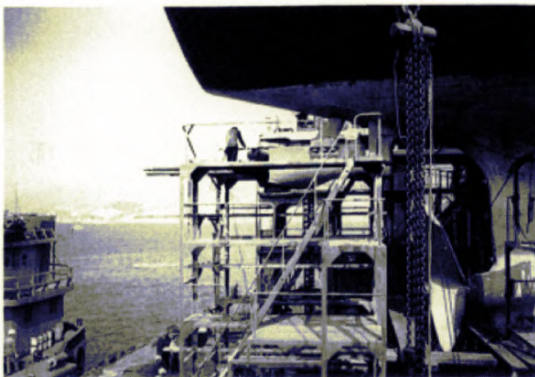
Photograph 1
Fractured rudder

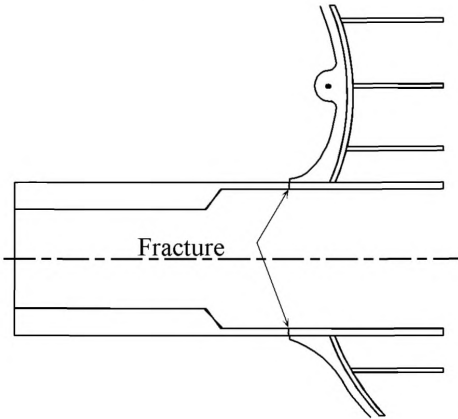
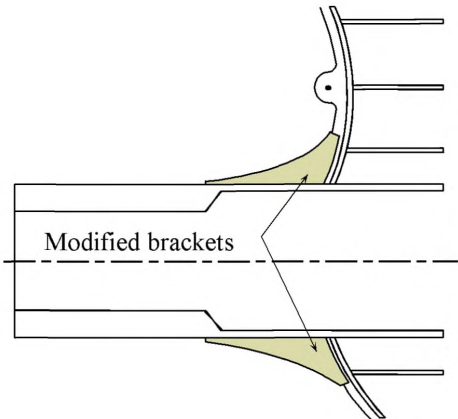
Notes on possible cause of damage		Notes on repairs	
<ol style="list-style-type: none"> 1. Fatigue fracture due to vibration. 		<ol style="list-style-type: none"> 1. Fractured tube is to be veed-out and welded from both sides. 2. Brackets are to be replaced by modified brackets with soft transition.

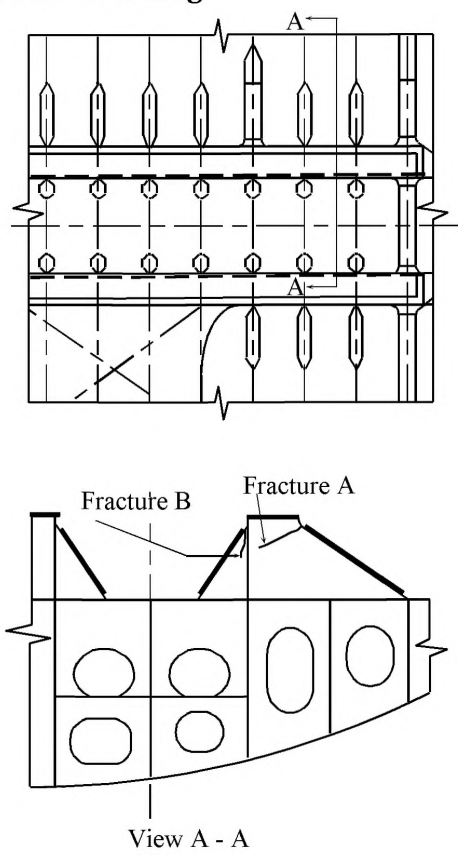
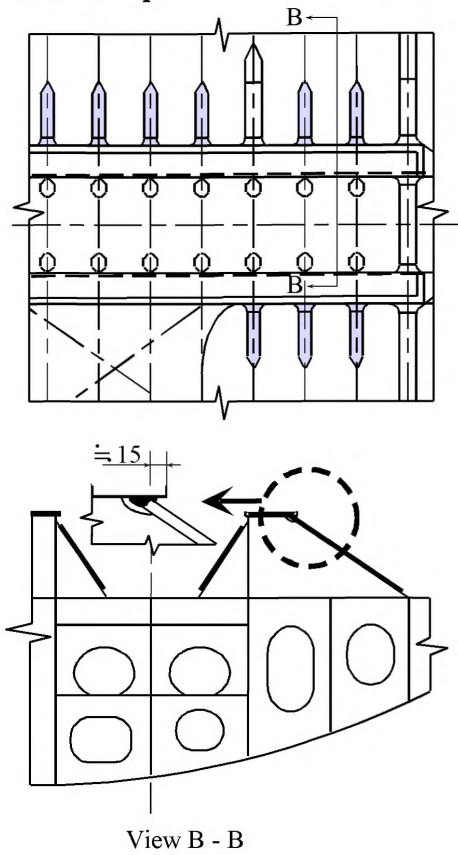
<p>View B - B</p>	
Notes on possible cause of damage		Notes on repairs	
<ol style="list-style-type: none"> 1. Vibration of main engine. 2. Insufficient strength of brackets at main engine foundation. 3. Insufficient pre-load bolts. 		<ol style="list-style-type: none"> 1. Fractures are to be veed-out and rewelded. 2. New modified brackets at main engine foundation. 3. Or insert pieces and additional flanges to increase section modulus of the brackets.
