No.76 IACS Guidelines for Surveys, Assessment and Repair of Hull Structure – Bulk Carriers

Guidelines for Surveys, Assessment and Repair of Hull
Structure

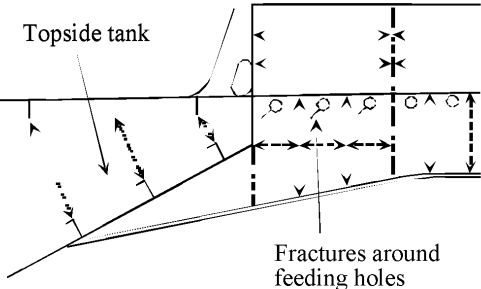
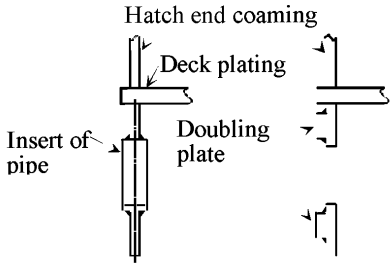
BULK CARRIERS		Guidelines for Surveys, Assessment and Repair of Hull Structure	
Part 1	Cargo hold region	Example No.	
Area 1	Deck structure	9	
Detail of damage	Fractures in hatch end beam around feeding holes		
Sketch of damage

<p style="text-align: center;">Detail</p>	
Notes on possible cause of damage 1. Inadequate reinforcement around feeding hole. 2. Corrosion.		Notes on repairs 1. Fractured part to be veed-out or cropped and renewed. 2. If the fractured part is free from corrosion, reinforcement should be considered.

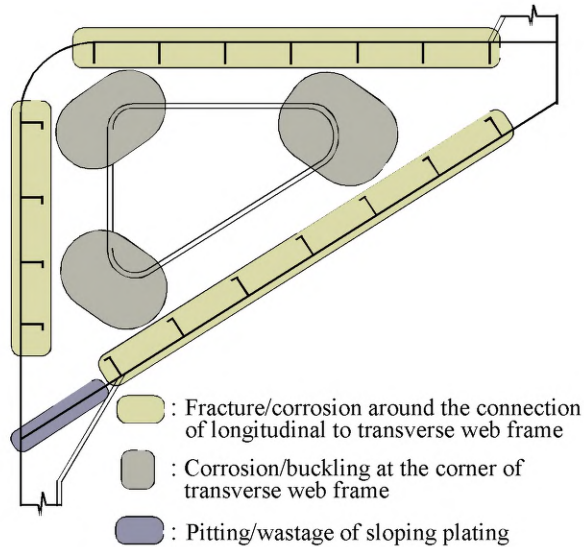
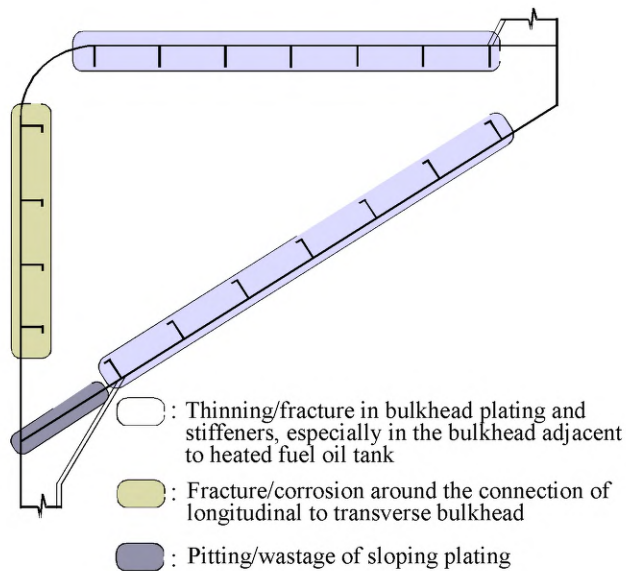
- (b) Structure subject to high stress
 - Face plates and web plates of transverse at corners
 - Connection of side longitudinal to transverse
 - (c) Areas susceptible to coating breakdown

- Back side of face plate of longitudinal
 - Welded joint
 - Edge of access opening
 - (d) Areas subjected to poor drainage
 - Web of side and sloping longitudinals

Figure 1 Topside tank - Potential problem areas

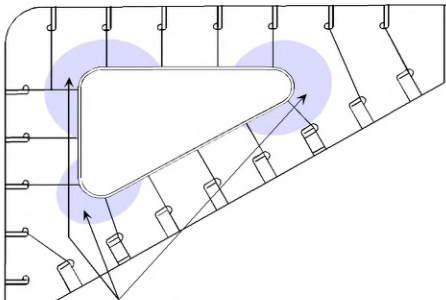
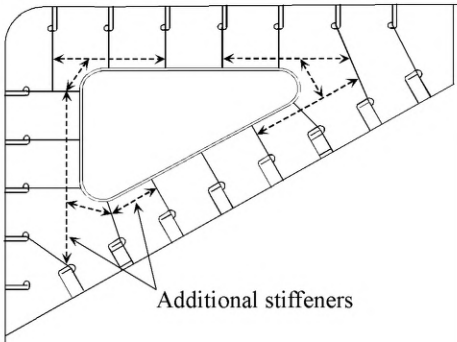
BULK CARRIERS		Guidelines for Surveys, Assessment and Repair of Hull Structure	
Part 1	Cargo hold region	Example No.	
Area 2	Topside tank structure	2-a	
Detail of damage	Thinning and subsequent buckling of web plating in the vicinity of the radii of the opening		
Sketch of damage		Sketch of repair

<p>Areas of excessive corrosion, and subsequent buckling and/or</p>

<p>Additional stiffeners</p>	
Notes on possible cause of damage		Notes on repairs	
<ol style="list-style-type: none"> 1. Insufficient buckling strength. 2. Corrosion due to stress concentration at corners. 		<ol style="list-style-type: none"> 1. Buckled plating is to be cropped and parts renewed, if necessary. 2. Additional stiffeners as shown above and/or renewal with plating of increased thickness should be considered.

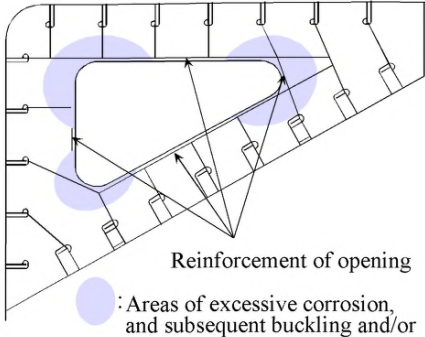
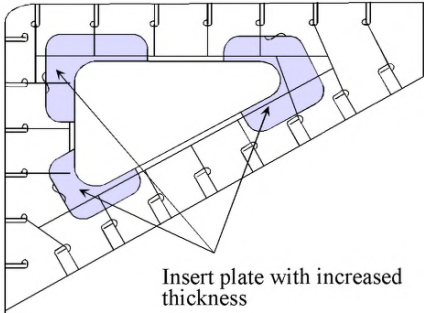
BULK CARRIERS		Guidelines for Surveys, Assessment and Repair of Hull Structure	
Part 1	Cargo hold region		Example No.
Area 2	Topside tank structure		2-c
Detail of damage		Thinning and subsequent buckling of web plating in the vicinity of the radii of the opening	
Sketch of damage		Sketch of repair

<p>Reinforcement of opening</p> <p>Areas of excessive corrosion, and subsequent buckling and/or</p>

<p>Insert plate with increased thickness</p>	
Notes on possible cause of damage		Notes on repairs	
<p>1. Additional stresses at the free edge of transverse web. (In Example 2-a - 2-c face plate is provided for the reinforcement of the opening.)</p>		<p>1. Corroded/buckled plating is to be cropped and part renewed with plating of increased thickness.</p>

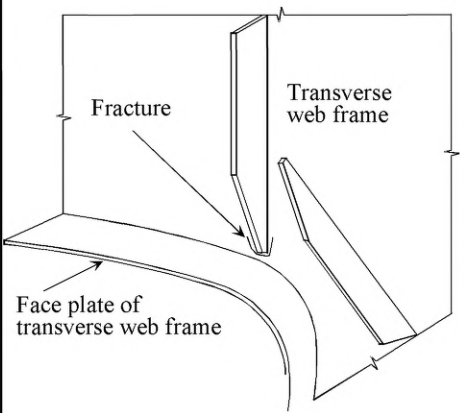
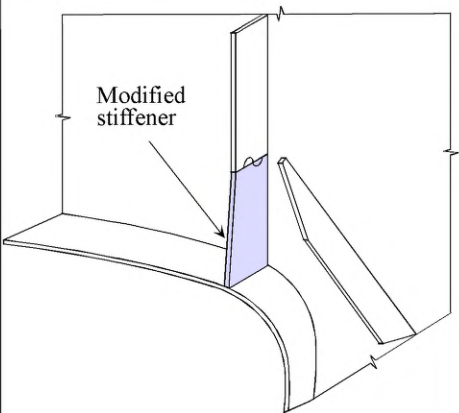
BULK CARRIERS		Guidelines for Surveys, Assessment and Repair of Hull Structure	
Part 1	Cargo hold region	Example No.	
Area 2	Topside tank structure	3	
Detail of damage		Fractures in transverse web at sniped end of stiffener	
Sketch of damage		Sketch of repair

Notes on possible cause of damage		Notes on repairs	
<ol style="list-style-type: none"> 1. Stress concentration. 		<ol style="list-style-type: none"> 1. Fracture can be veed-out and welded provided the plating is not generally corroded. If necessary, fractured plating should be cropped and renewed. 2. Excessive stress concentration at the end of stiffener should be avoided.

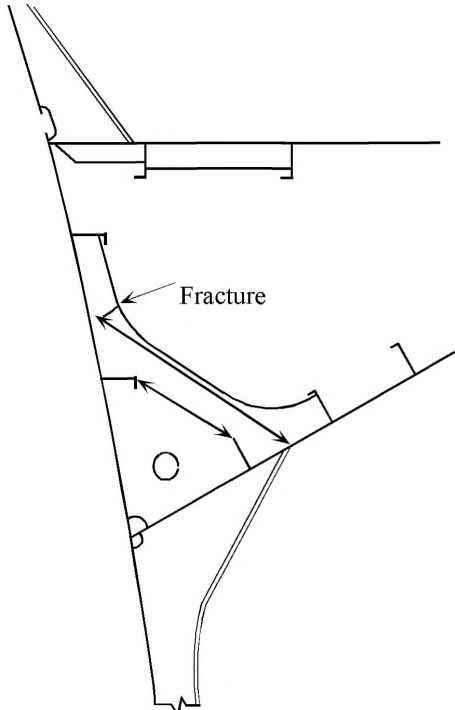
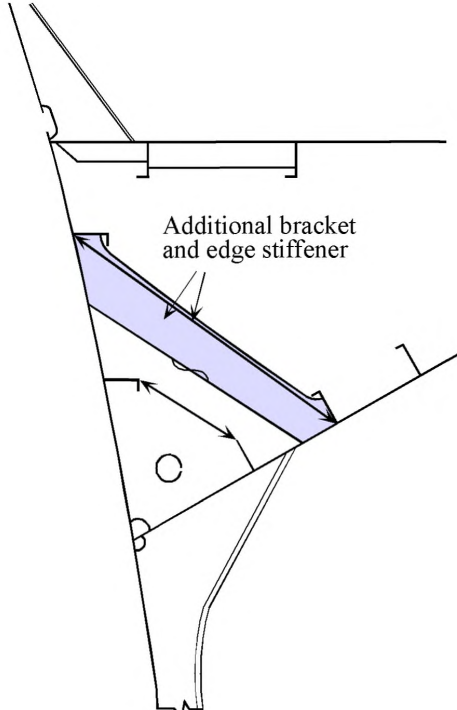
BULK CARRIERS		Guidelines for Surveys, Assessment and Repair of Hull Structure	
Part 1	Cargo hold region	Example No.	
Area 2	Topside tank structure	7-b	
Detail of damage		Fractures in transverse bracket	
Sketch of damage		Sketch of repair

Notes on possible cause of damage		Notes on repairs	
<ol style="list-style-type: none"> 1. Insufficient strength. 2. Corrosion. 		<ol style="list-style-type: none"> 1. Fractured part to be cropped and renewed. 2. If the fractured part is free from corrosion, increased size and thickness should be considered. Partial renewal of the bracket may be accepted depending on the nature of the fracture.

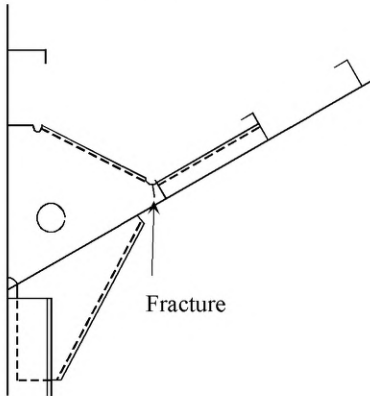
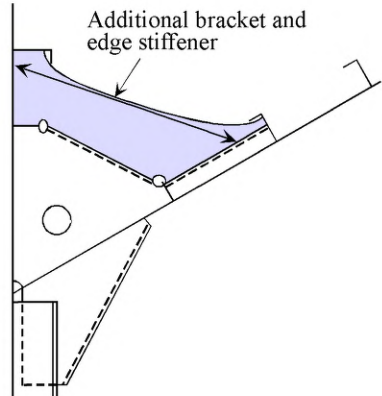
BULK CARRIERS		Guidelines for Surveys, Assessment and Repair of Hull Structure	
Part 1	Cargo hold region	Example No.	
Area 2	Topside tank structure	7-c	
Detail of damage		Fractures at toes of transverse bracket	
Sketch of damage		Sketch of repair

Notes on possible cause of damage		Notes on repairs	
<ol style="list-style-type: none"> 1. Stress concentration due to the shape of the bracket. 		<ol style="list-style-type: none"> 1. Cracked weld to be veed-out and rewelded.

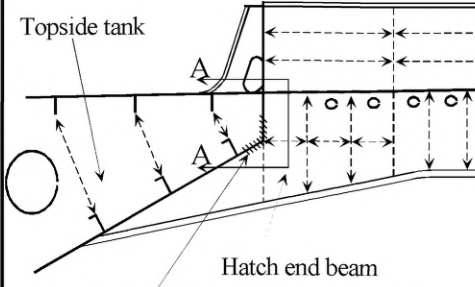
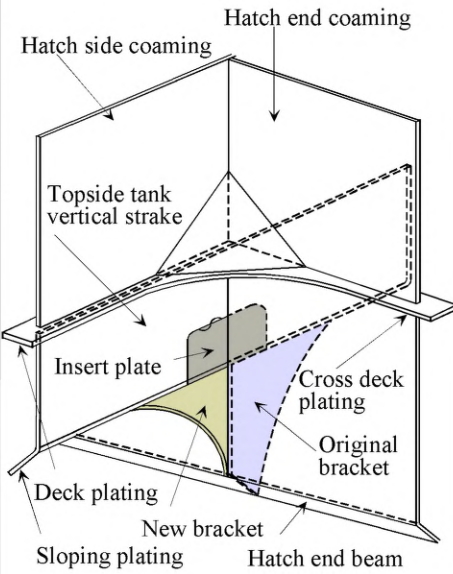
BULK CARRIERS		Guidelines for Surveys, Assessment and Repair of Hull Structure	
Part 1	Cargo hold region	Example No. 8	
Area 2	Topside tank structure		
Detail of damage		Fractures in sloping plating and vertical strake initiated from the connection of topside tank to hatch end beam	
Sketch of damage		Sketch of repair

Notes on possible cause of damage		Notes on repairs	
<ol style="list-style-type: none"> 1. Stress concentration at the connection of hatch end beam to topside tank. 		<ol style="list-style-type: none"> 1. Fractured part to be cropped and renewed with increased thickness. 2. Additional bracket should be considered for reinforcement.

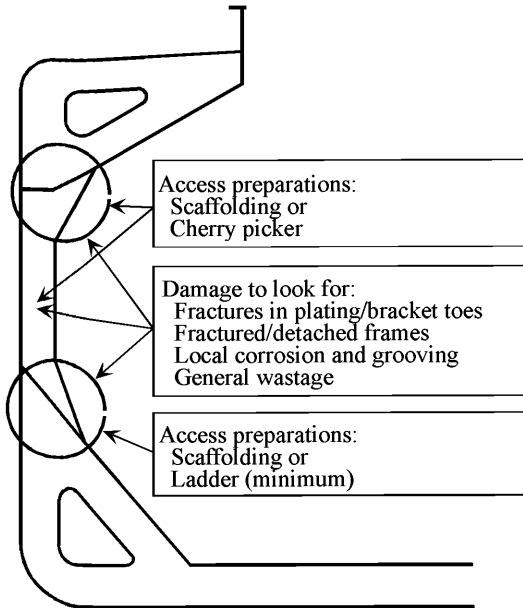
Figure 1
Side shell frame - Potential problem areas

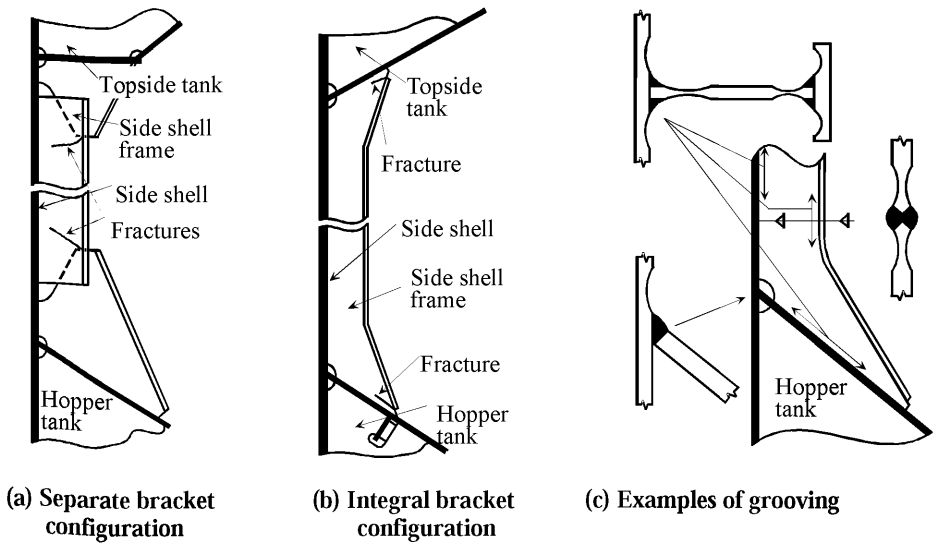
Figure 2 Damages to side shell frame - Potential problem areas

(Note) The type of bracket configuration used will, to a large extent, dictate the location and extent of fracture. Where separate brackets are employed, the fracture location is normally at the bracket toe position on the frames, whereas with integral brackets the location is at the toe position on the hopper and topside tank.

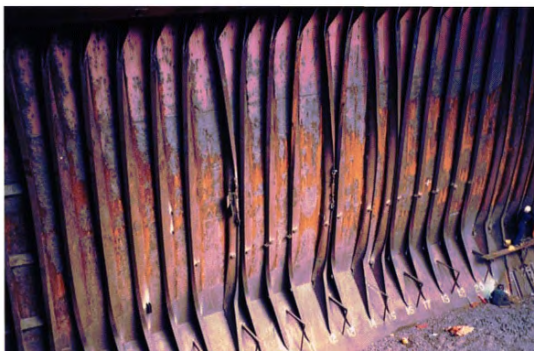
Photograph 1 Collapsed side shell frames (See Example 4)

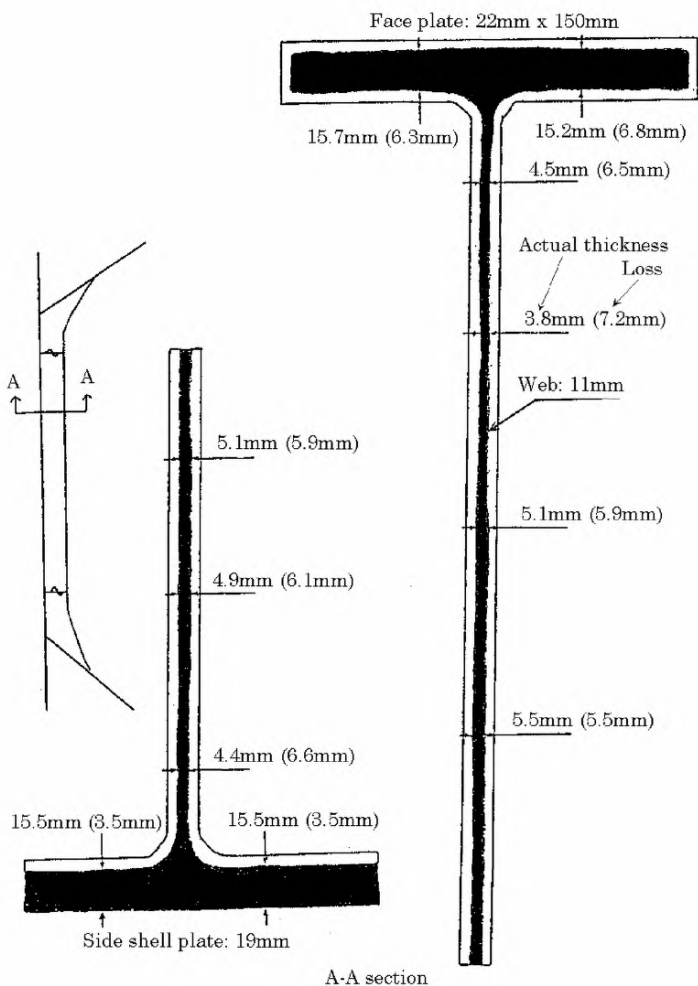
- 2.1.1** Attention is drawn to the fact that side shell frames may be significantly weakened by loss of thickness although diminution and deformations may not be apparent. Inspection should be made after the removal of any scale or rust deposit. Thickness measurements may be necessary, particularly if the corrosion is smooth and uniform, to determine the condition of the structure (See **Figure 5**).

Figure 5 Uniform corrosion of side shell frame

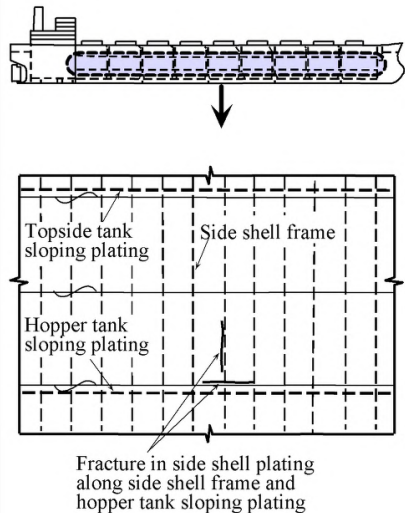
BULK CARRIERS		Guidelines for Surveys, Assessment and Repair of Hull Structure
Part 1	Cargo hold region	Example No.
Area 3	Cargo hold side structure	3
Detail of damage	Fractures in side shell frame/lower bracket and side shell plating near hopper	
Sketch of damage		Sketch of repair

<p>Topside tank sloping plating</p> <p>Side shell frame</p> <p>Hopper tank sloping plating</p> <p>Fracture in side shell plating along side shell frame and hopper tank sloping plating</p>

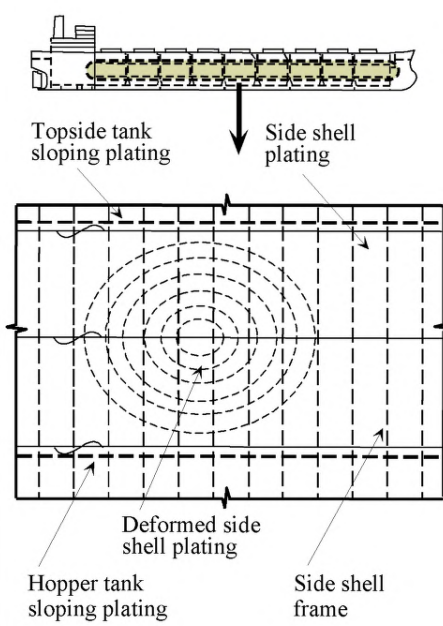
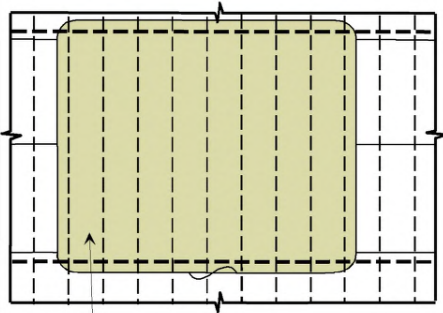
BULK CARRIERS		Guidelines for Surveys, Assessment and Repair of Hull Structure	
Part 1	Cargo hold region	Example No.	
Area 3	Cargo hold side structure	4	
Detail of damage		Deformation of side shell plating	
Sketch of damage		Sketch of repair

<p>Topside tank sloping plating</p> <p>Side shell plating</p> <p>Deformed side shell plating</p> <p>Hopper tank sloping plating</p> <p>Side shell frame</p>

<p>Part renewal including side shell frames</p>	
Notes on possible cause of damage		Notes on repairs	
<ol style="list-style-type: none"> Insufficient stiffness of side shell frames due to buckling and/or detachment of side shell frames due to corrosion. Heavy weather. 		<ol style="list-style-type: none"> Deformed side shell plating including side shell frames should be cropped and renewed.

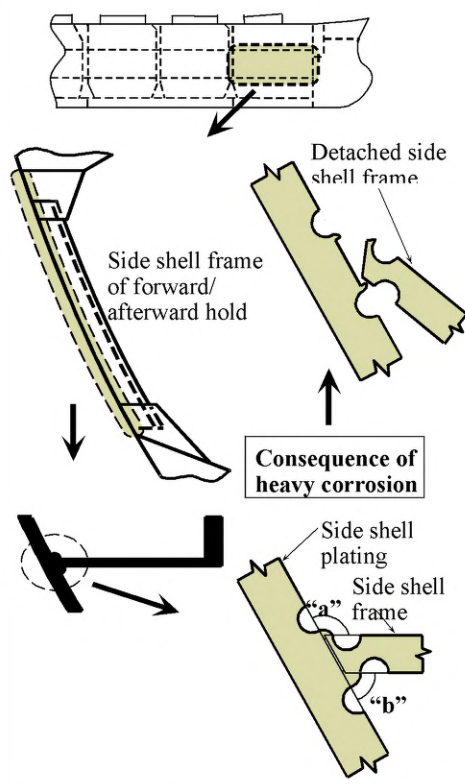
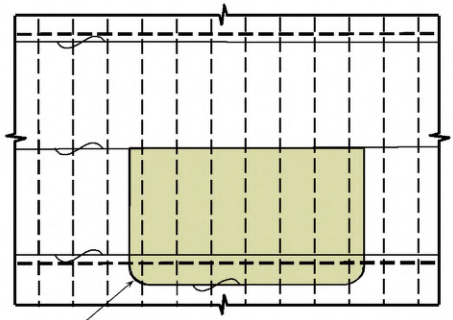
BULK CARRIERS		Guidelines for Surveys, Assessment and Repair of Hull Structure	
Part 1	Cargo hold region	Example No.	
Area 3	Cargo hold side structure	5	
Detail of damage		Adverse effect of corrosion on the frame of forward/afterward hold	
Sketch of damage		Sketch of repair

Notes on possible cause of damage		Notes on repairs	
<ol style="list-style-type: none"> 1. Heavy corrosion (grooving) of side shell frame along side shell plating and difference of throat thickness "a" from "b". (Since original throat thickness of "a" is usually smaller than that of "b", if same welding procedure is applied, the same corrosion has a more severe effect on "a", and may cause collapse and/or detachment of side shell frame.) 		<ol style="list-style-type: none"> 1. Sketch of repair applies when damage extends over several frames. 2. Isolated fractures may be repaired by veeing-out and rewelding. 3. Isolated cases of grooving may be repaired by build up of welding.

<p>The sketch of repair shows a rectangular area with dashed lines and arrows indicating the repair process. The area is shaded green, representing the part to be renewed. The repair involves part renewal including side shell frames and hopper plating, as found necessary, and deep penetration welding at the connections of side shell frames to side shell plating.</p> <ol style="list-style-type: none"> 1. Part renewal including side shell frames and hopper plating, as found necessary 2. Deep penetration welding at the connections of side shell frames to side shell plating

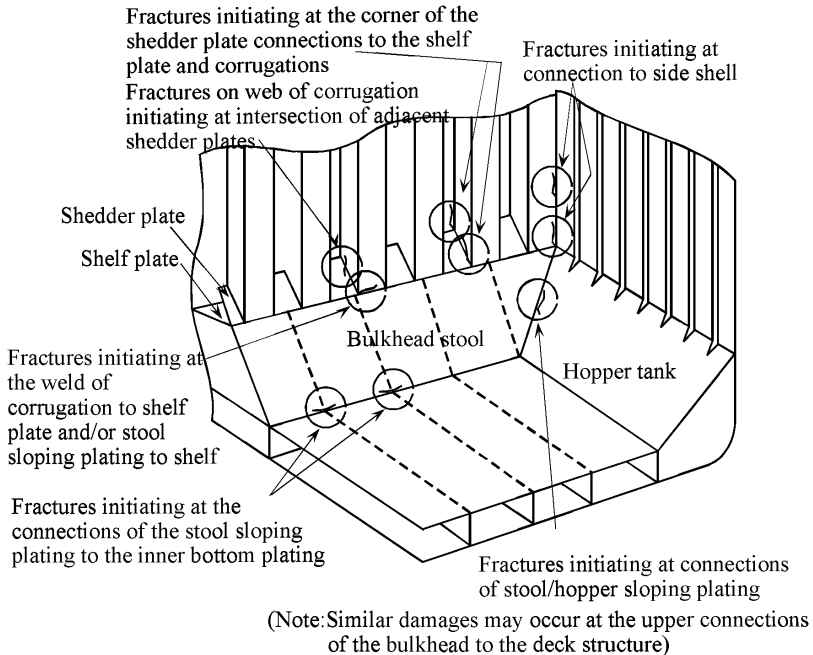
Figure 2 Typical fracturing at the connection of transverse bulkhead structure

2.3.1 Fractures usually occur at the boundaries of corrugations and bulkhead stools particularly in way of shelf plates, shedder plates, deck, inner bottom, etc. (See **Figure 2**).

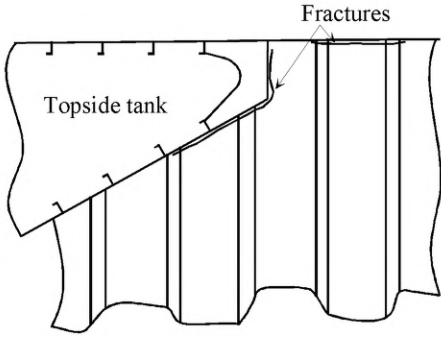
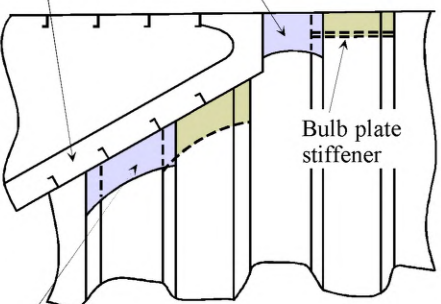
BULK CARRIERS		Guidelines for Surveys, Assessment and Repair of Hull Structure	
Part 1	Cargo hold region	Example No.	
Area 4	Transverse bulkhead and associated structure in cargo hold	2	
Detail of damage		Fractures at the upper boundaries to topside tanks	
Sketch of damage		Sketch of repair

Notes on possible cause of damage		Notes on repairs	
<ol style="list-style-type: none"> 1. Damage due to poor design and/or defective welds. 		<ol style="list-style-type: none"> 1. Fractures may be veed-out and rewelded. If necessary corrugated plating cropped and renewed. 2. It is recommended that reinforcement as shown above be incorporated, giving due consideration to the following criteria: <ol style="list-style-type: none"> 2.1 It is important to have the gusset plates well aligned with the transverse structure inside the tank. Gusset plates may be joggled to obtain this alignment. 2.2 If there is no transverse web already existing inside the topside tank and in line with the flanges of corrugation or gusset plates, reinforcement as shown above to be fitted.

<p>Continuous or intercostal reinforcement in line with flanges or gussets where not already fitted</p> <p>Adjacent to the topside tank either a gusset to a bulb plate stiffener may be</p>

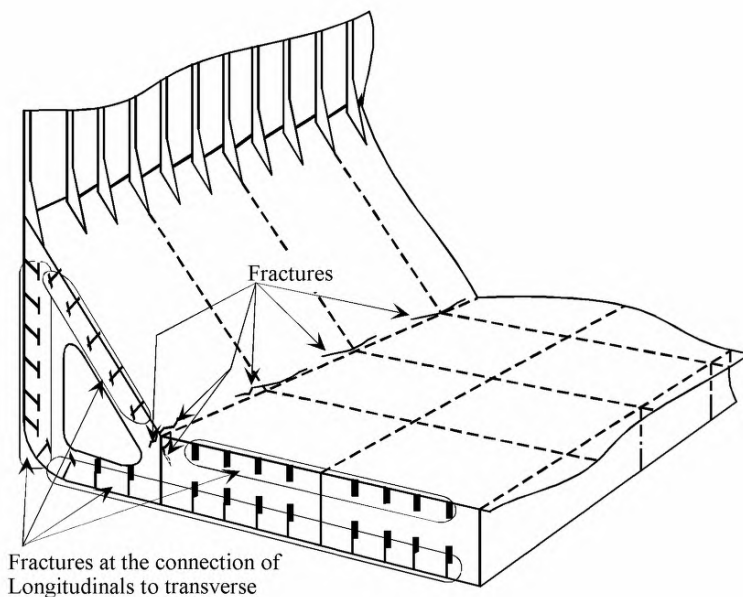
Figure 1 Typical fractures in the connection of hopper sloping plating to inner bottom (tank top) and longitudinals to transverse (or transverse bulkhead)

- 2.3.1 Fractures will normally be found by close-up inspection. Fractures that

extend through the thickness of the plating or through the welds may be observed during pressure testing of the double bottom tanks (See **Figure 1** and **2** of **Area 4**).

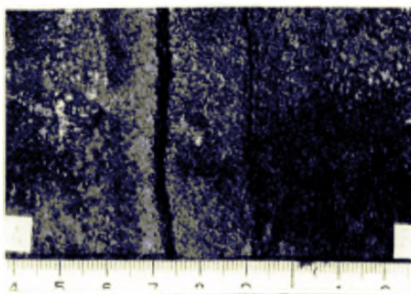
- 4.1.1** Hull structure below the water line can usually be inspected only when the ship is dry-docked. The opportunity should be taken to inspect the external plating thoroughly. The level of wastage of the bottom plating may have to be established by means of thickness measurements.
- 4.1.2** Severe grooving along welding of bottom plating is often found (See **Photographs 1** and **2**). This grooving can be accelerated by poor maintenance of the protective coating and/or sacrificial anodes fitted to the bottom plating.
- 4.1.3** Bottom or “docking” plugs should be carefully examined for excessive corrosion along the edge of the weld connecting the plug to the bottom plating.

Photograph 1
Grooving corrosion of welding of bottom plating

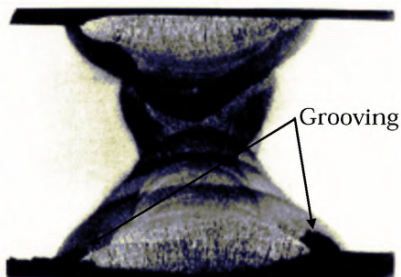
Photograph 2
Section of the grooving shown in Photograph 1

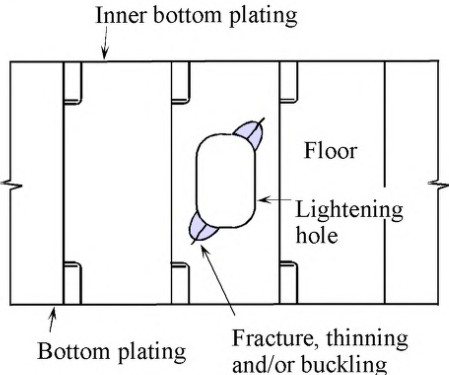
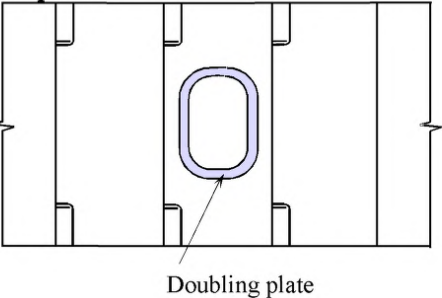
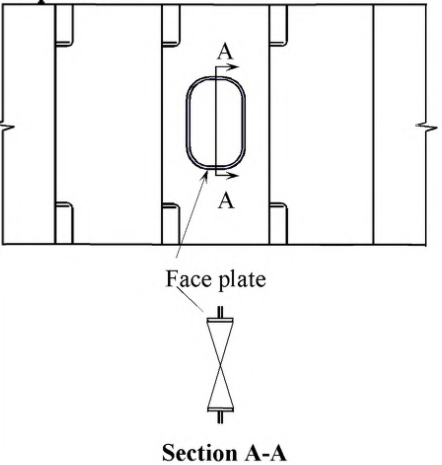
BULK CARRIERS		Guidelines for Surveys, Assessment and Repair of Hull Structure	
Part 1	Cargo hold region	Example No.	
Area 5	Double bottom structure including hopper	2	
Detail of damage		Fractures, corrosion and/or buckling of floor/girder around lightening hole	
<p>Sketch of damage</p>

<p>Notes on possible cause of damage</p> <ol style="list-style-type: none"> 1. Insufficient strength due to lightening hole. 2. Fracture, corrosion and/or buckling around lightening hole due to high stress. 		<p>Notes on repairs</p> <ol style="list-style-type: none"> 1. Fractured, corroded and/or buckled plating should be cropped and renewed if considered necessary. 2. Appropriate reinforcement should be considered.

<p>Sketch of repair</p> <p>Repair A</p>

<p>Repair B</p>

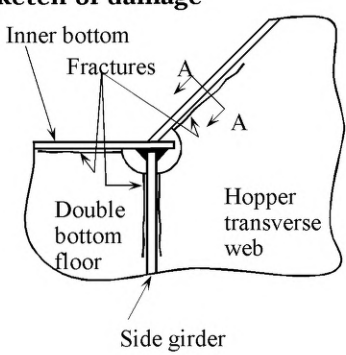
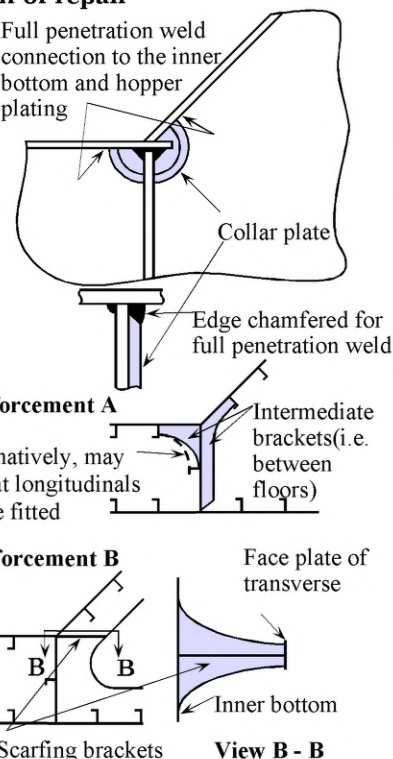
<p>View A - A Transverse fractures in hopper web plating into possibly extending into the hopper sloping plating</p>

<p>Reinforcement A Alternatively, may stop at longitudinals where fitted</p> <p>Reinforcement B</p> <p>View B - B</p>	
<p>Notes on possible cause of damage</p> <ol style="list-style-type: none"> 1. The damage is partly due to stress concentration at the edges of the weld .created by the presence of the deflections in the inner bottom/hopper plating. 		<p>Notes on repairs</p> <ol style="list-style-type: none"> 1. The fracture in the weld and/or plating is veed-out/cropped and renewed as appropriate. 2. The cut-outs are eliminated by introducing suitable collar plates with emphasis on edge preparation and sequence of welding as shown above. 3. Further reinforcements may be incorporated as shown above and depending on the judged cause of damage.

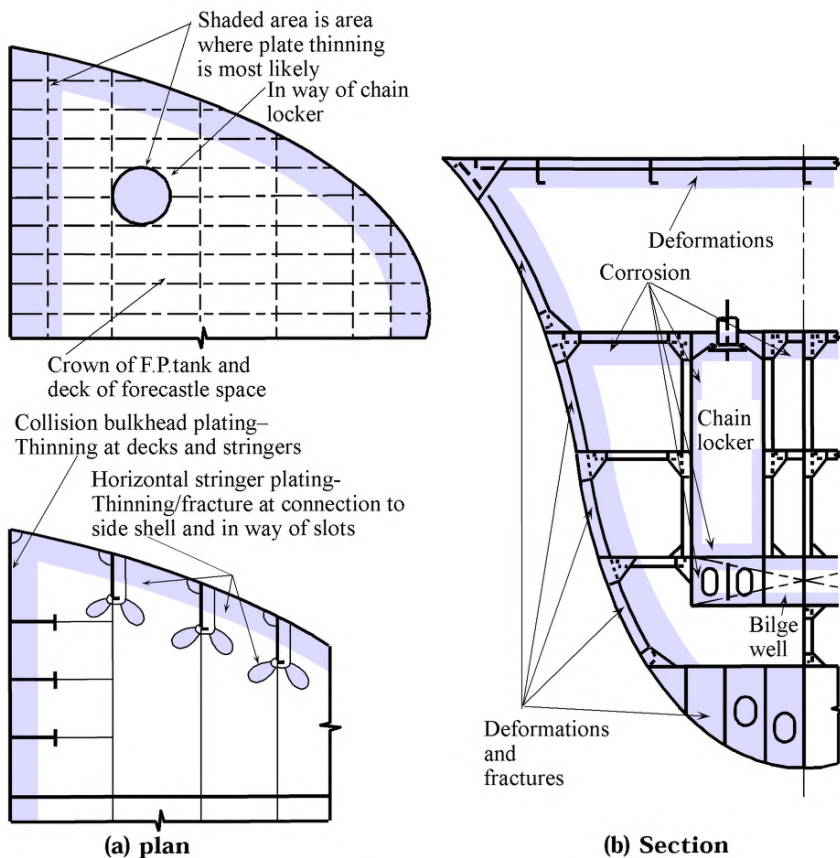
Fig 1 Fore end structure - Potential problem areas

- 2.3.1 Fractures in the fore peak tank are normally found by close-up inspection of the internal structure.
- 2.3.2 Fractures are often found in transition region and reference should be made to **Part 1, Area 2** and **3**.

2.3.3 Fractures that extend through the thickness of the plating or through the boundary welds may be observed during pressure testing of tanks.

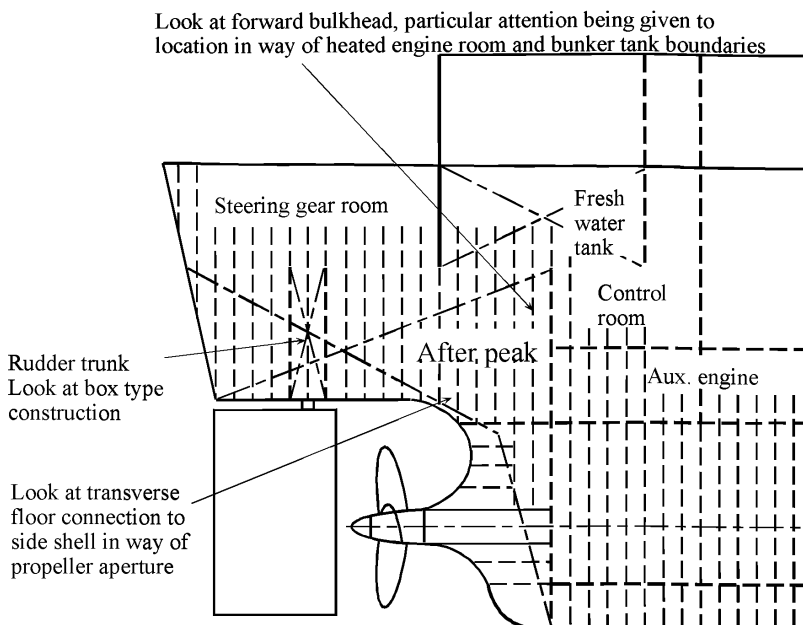
Figure 1 Aft end structure - Potential problem areas

- 2.3.1 Fractures in weld at floor connections and other locations in the aft peak tank and rudder trunk space can normally only be found by close-up inspection.
- 2.3.2 The structure supporting the rudder carrier may fracture and/or deform due to excessive load on the rudder. Bolts connecting the rudder carrier to the steering gear flat may also suffer damage under such load.

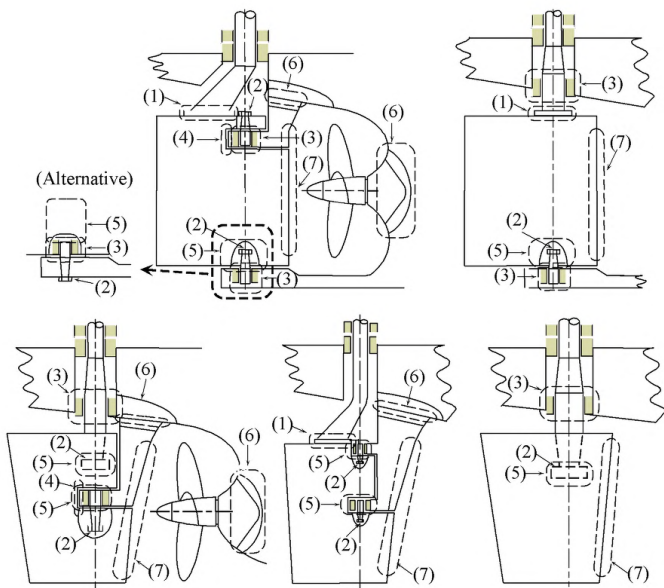
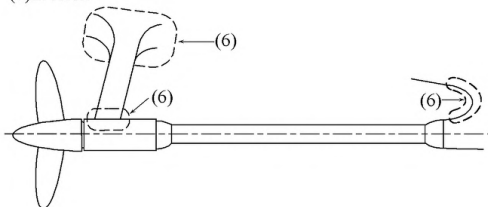
Figure 2 Potential problem areas

- (1) Fractures and loose coupling bolts
- (2) Loose nut
- (3) Wear (excessive bearing clearance)
- (4) Fractures in way of pintle cutout
- (5) Fractures in way of removable access plate
- (6) Fractures
- (7) Erosion

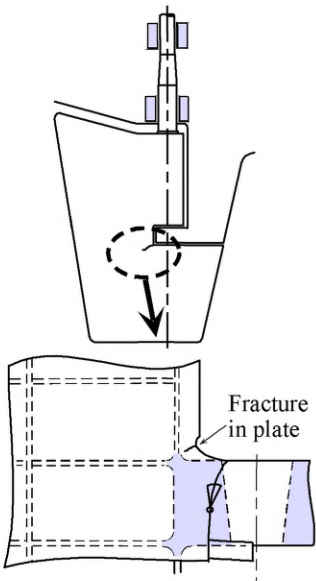
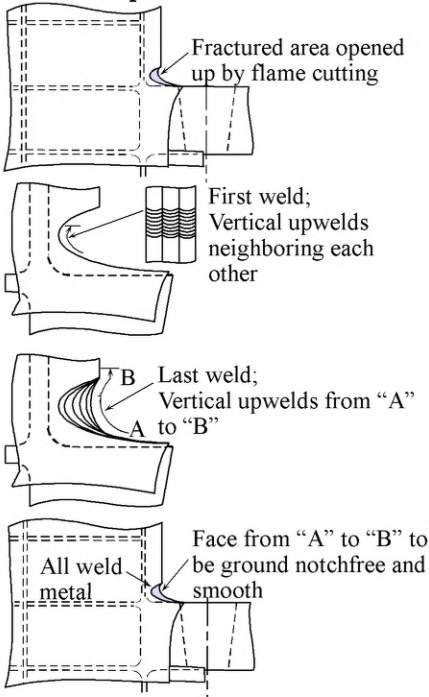
Notes on possible cause of damage		Notes on repairs	
<ol style="list-style-type: none"> 1. Stress concentration due to inadequate local design and/or fabrication notches in way of the butt weld between cast piece and plating. 		<ol style="list-style-type: none"> 1. Grooving-out and welding of the fracture is not always adequate (metallurgical notch in way of a high stressed area). 2. In the proposed repair procedure the metallurgical notches are shifted into a zone exposed to lower stresses. 3. After welding a modification of the radius according to the proposal in Example 5 is to be carried out. 4. In case of very small crack it can be ground off by increasing the radius.

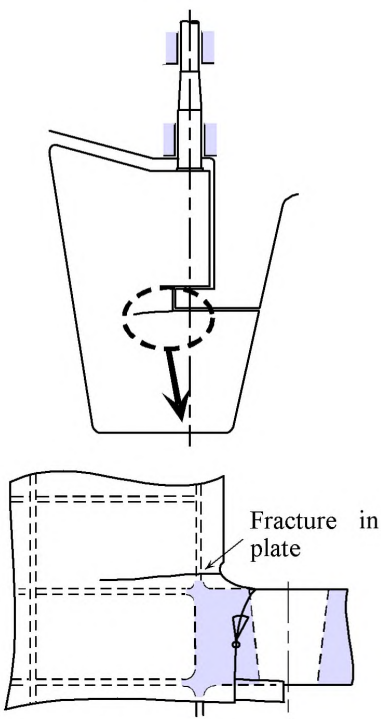
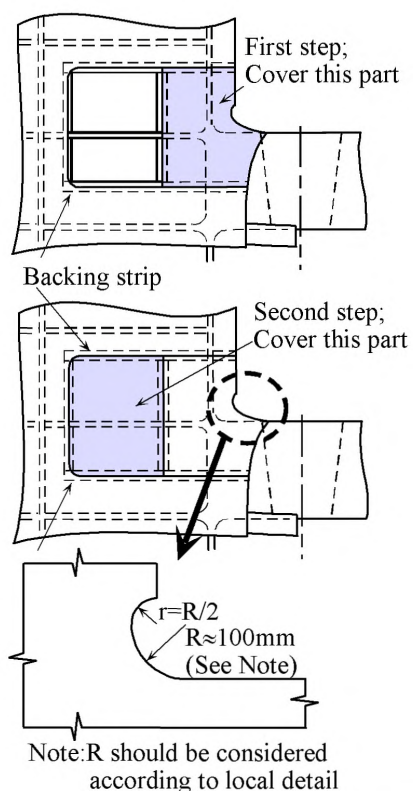
Detail of damage Fractures in rudder plating of semi-spade rudder extending beyond the vertical web

| <p>Notes on possible cause of damage</p> <ol style="list-style-type: none"> 1. Stress concentration due to inadequate local design and/or fabrication notches in way of the butt weld between cast piece and plating. | <p>Notes on repairs</p> <ol style="list-style-type: none"> 1. Fractured plating is to be cut-out. 2. Internal structures are to be checked. 3. Cut-out is to be closed by an insert plating according to the sketch (welding only from one side is demonstrated). 4. Modification of the radius. 5. In case of a new cast piece, connection with the plating is to be shifted outside the high stress area. |

<p style="text-align: center;">Note: R should be considered according to local detail</p>
---	--

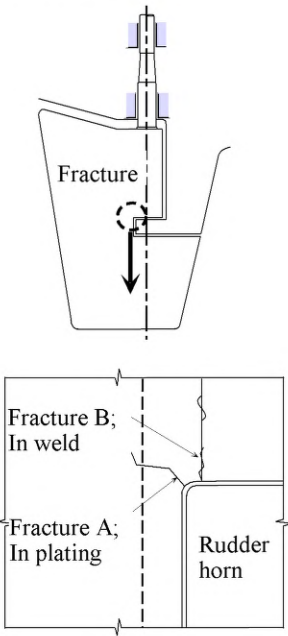
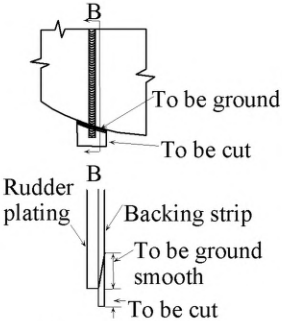
Notes on possible cause of damage		Notes on repairs	
<ol style="list-style-type: none"> Inadequate design for stress concentration in way of pintle bearing (Fracture A). Imperfection in welding seam (Fracture B). 		<ol style="list-style-type: none"> Fractured part to be cropped off. Repair by two insert plates of modified, stress releasing contour. For the vertical seam no backing strip is used 100mm off contour, welding from both sides, to be ground after welding. Variant (See Detail A): Repair as mentioned under 2 with the use of backing strip for the complete vertical seam. After welding backing strip partly removed by grinding.

<p>The sketch of repair shows two steps. The 'Second step' involves covering a rectangular area with a radius of R=350mm. The 'First step' involves covering a smaller area with a radius of R=100mm. A note indicates that the radii should be considered according to local detail and that the new contour should be ground smooth. A reference to 'See Detail A' is included.</p> <p>Note: 1.R should be considered according to local detail 2.New contour should be ground smooth</p>

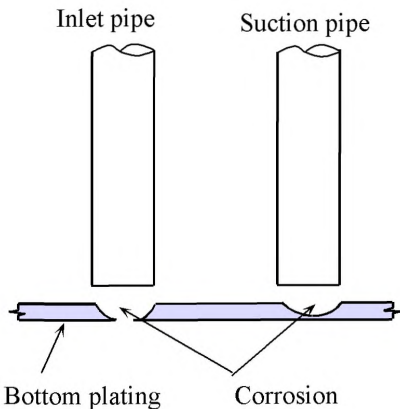
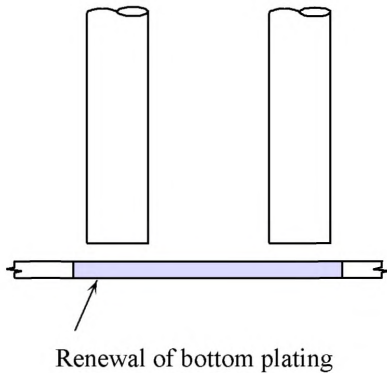
BULK CARRIERS		Guidelines for Surveys, Assessment and Repair of Hull Structure	
Part 3	Machinery and accommodation spaces		Example No.
Area 1	Engine room structure		3
Detail of damage		Corrosion in bottom plating under inlet/suction/pipe in way of bilge tank in engine room	
<p>Sketch of damage</p>

<p>The sketch shows the same two vertical pipes on the bottom plating. The bottom plating has been replaced with a thicker section, labeled 'Renewal of bottom plating'. An arrow points from the label to the new plating section.</p>	
<p>Notes on possible cause of damage</p> <ol style="list-style-type: none"> 1. Heavy corrosion of bottom plating under the inlet/suction pipe. 		<p>Notes on repairs</p> <ol style="list-style-type: none"> 1. Corroded bottom plating is to be cropped and part renewed. Thicker plate is preferable. 2. Replacement of pipe end by enlarged conical opening (similar to suction head in ballast tank) is preferable.
